## QUALITY TEST CERTIFICATE

Test report No. 10995.02 / 14

| Equipment under test | <b>Incremental Encoder</b><br>SN<br>Quantity | <b>HOG165C DN 1024 I</b><br>700001050790<br>1 unit | |
| Purpose | <b>Tests for the certification of the degrees of protection IPX6 and the corrosive resistance</b> | | |

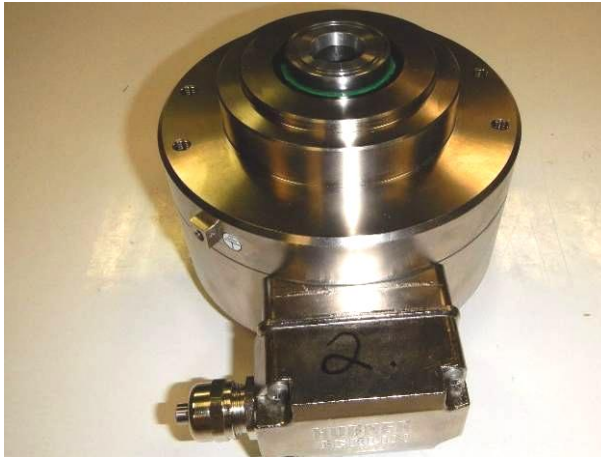
**Picture 1**  
**Incremental encoder HOG165C DN 1024 I**  
**delivery status**  
*before the protection against water jets test IPX6*

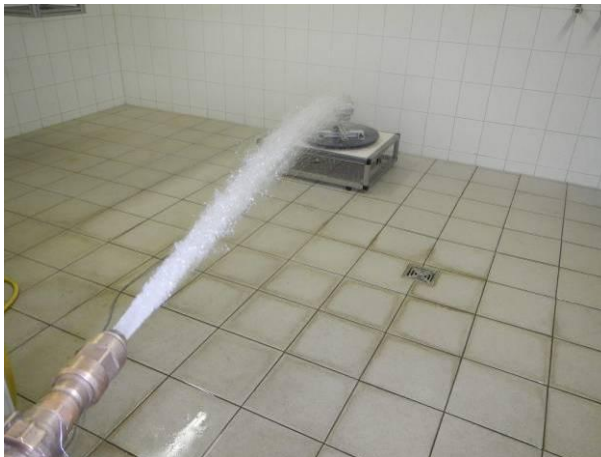
**Picture 3**  
**Incremental encoder HOG165C DN 1024 I**  
**on the turn table with standardized water jet**  
*during the protection against water jets test IPX6*

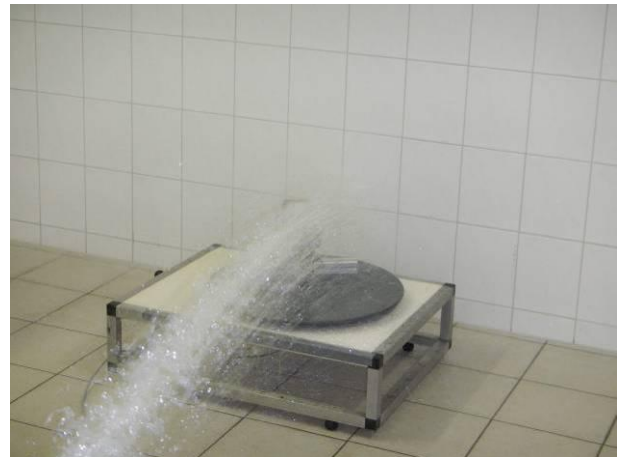
**Picture 4**  
**Incremental encoder HOG165C DN 1024 I**  
**on the turn table with standardized water jet**  
*during the protection against water jets test IPX6*

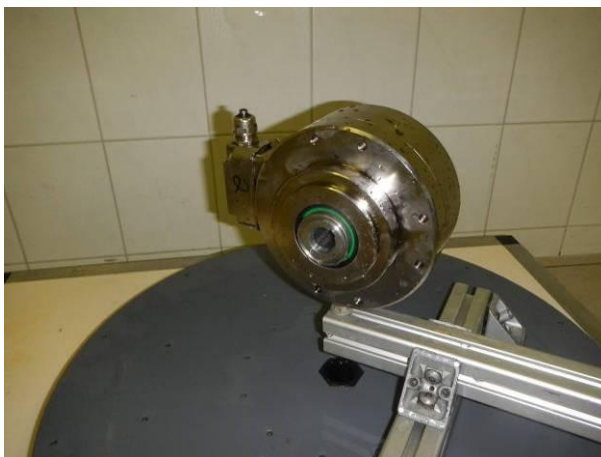
- Without external damage or any other alterations.
- No traces of water was detected inside the specimen.

**Picture 5**  
**Incremental encoder HOG165C DN 1024 I**  
**without any alterations**  
*after the protection against water jets test IPX6*

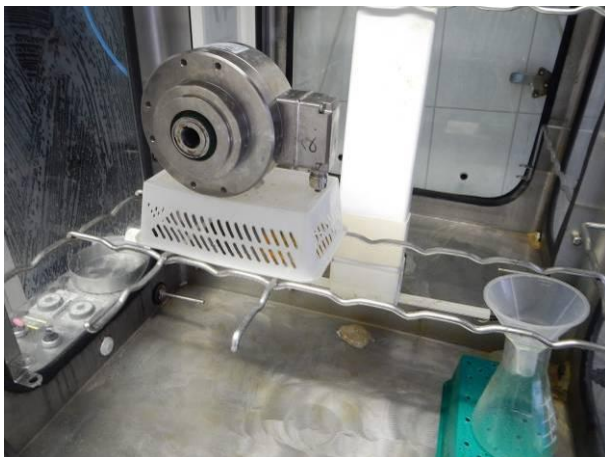
**Picture 9**  
**Incremental encoder HOG165C DN 1024 I**  
**in the salt mist chamber 47**  
*before the salt mist Kb*

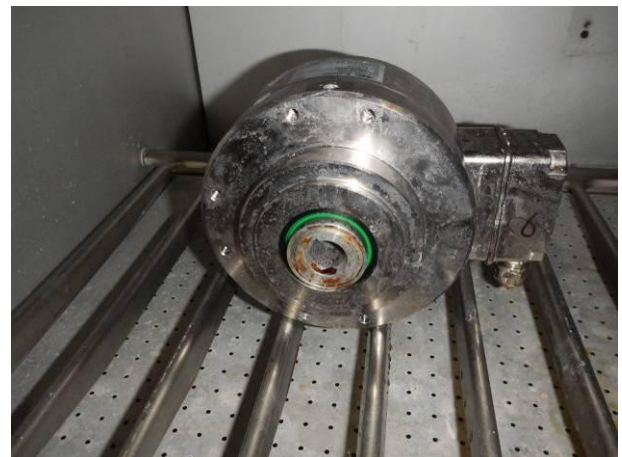
**Picture 10**  
**Incremental encoder HOG165C DN 1024 I**  
**in the climatic chamber 3**  
*during the salt mist Kb*

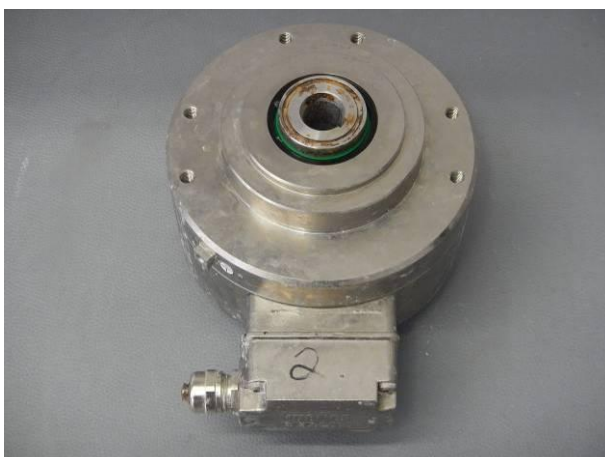
- Corrosive alterations were determined.
- Red rust was detected on the bearing.
- Dark spots and white deposits were detected on the surface of the specimen.

**Picture 11**  
**Incremental encoder HOG165C DN 1024 I**  
**with visible corrosive alterations**  
*after the salt mist Kb*

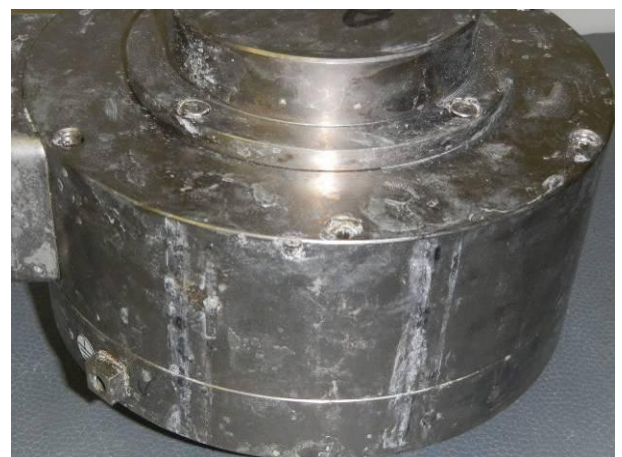
**Picture 12**  
**Incremental encoder HOG165C DN 1024 I**  
**with dark spots and white deposits**  
*after the salt mist Kb*

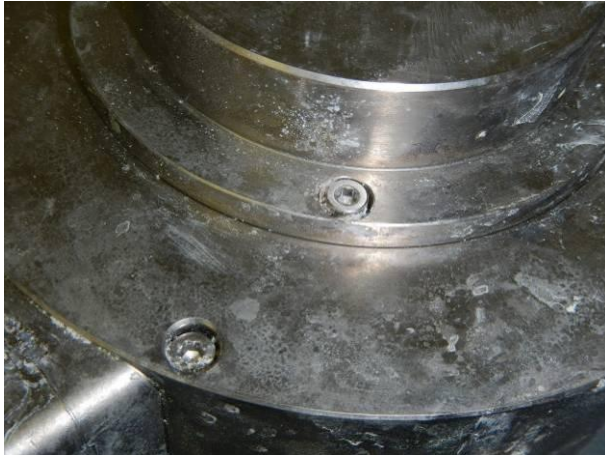
**Picture 13**  
Incremental encoder HOG165C DN 1024 I  
with dark spots and white deposits  
*after the salt mist Kb*

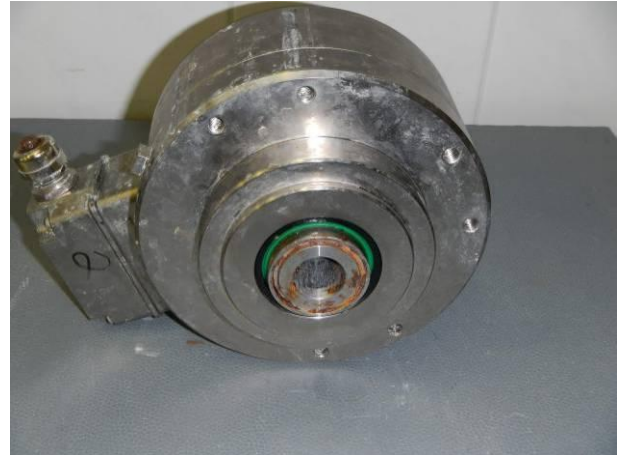
**Picture 14**  
Incremental encoder HOG165C DN 1024 I  
with red rust on the bearing  
*after the salt mist Kb*
