CERTIFICATE of QUALITY TEST

Test report - No. 10996.04 / 14

Test of the dynamic-mechanical robustness of the **Sensor Head MHAP** under defined environmental conditions.

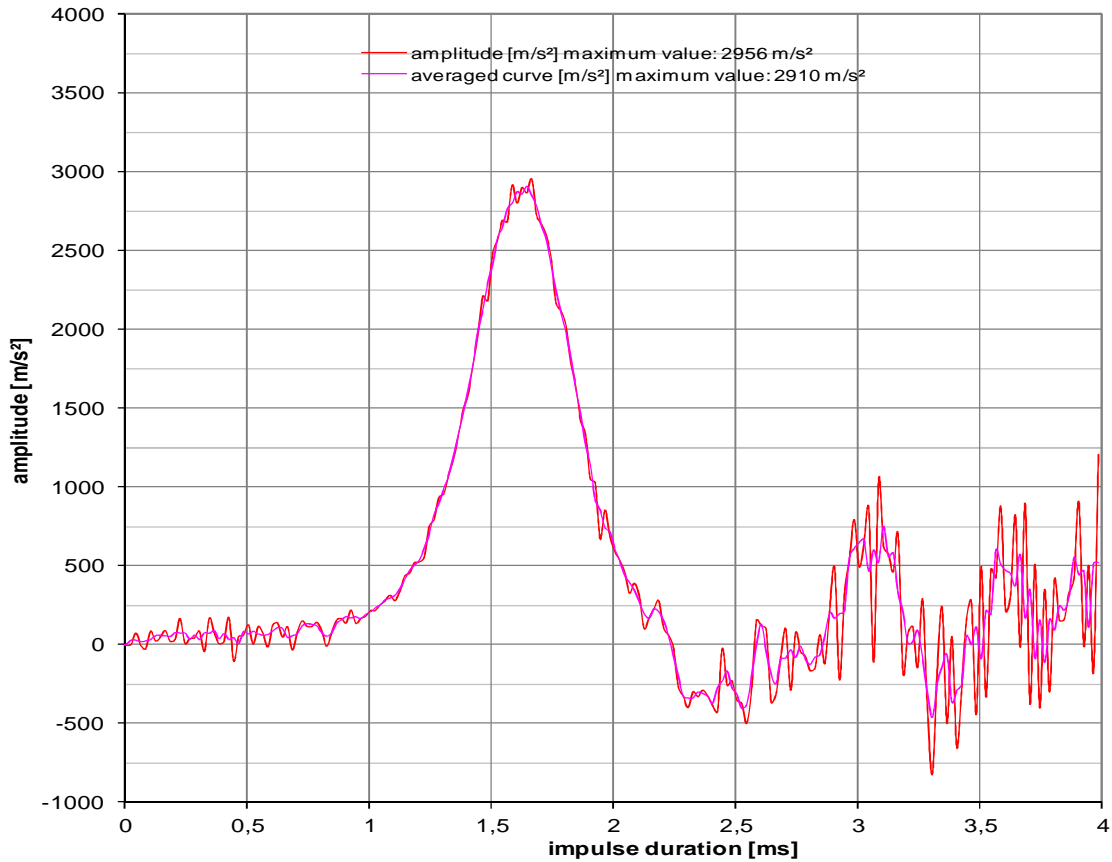
Shock, half-sine (control channel)

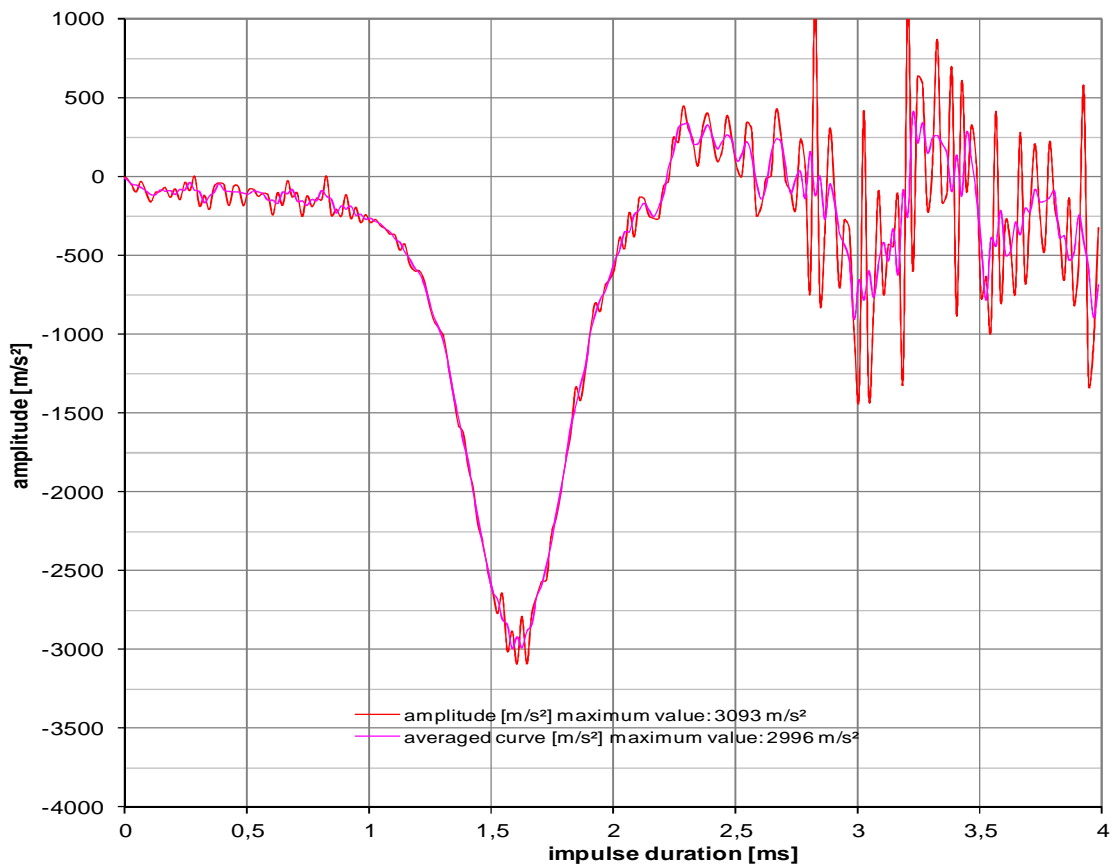
Shock, half-sine, inverted (control channel)

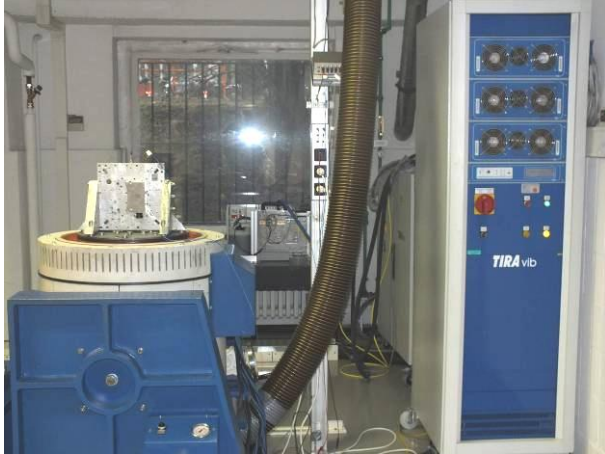
picture 1
Sensor Head MHAP
on the vibration test device
during vibration test in X-axis

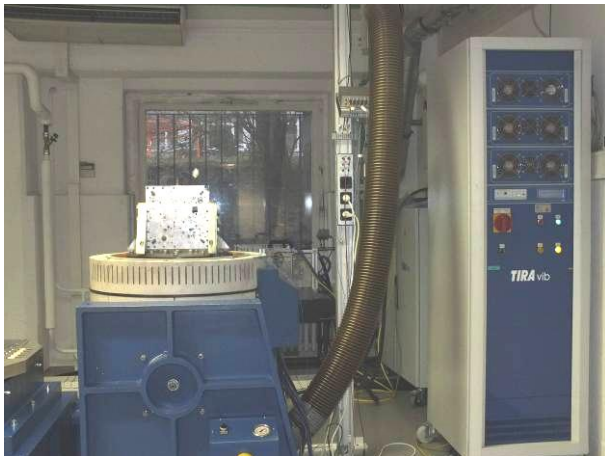
picture 3
Sensor Head MHAP
specimens on the vibration test device
during vibration test in Y-axis

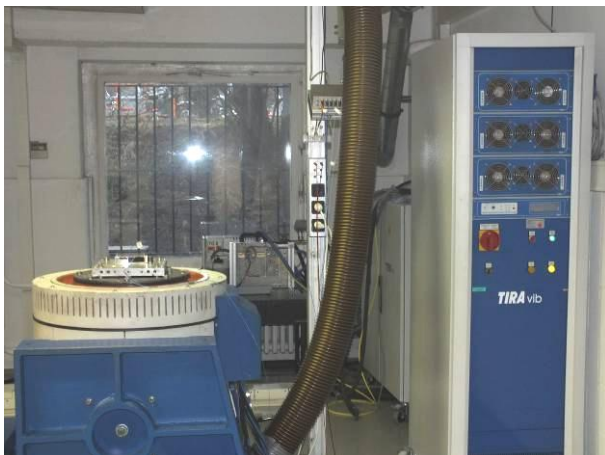
picture 5
Sensor Head MHAP
specimen on the vibration test device
during vibration test in Z-axis

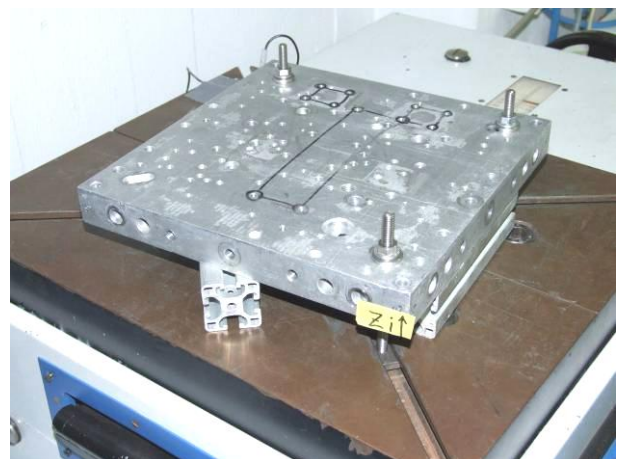
picture 12
Sensor Head MHAP
on the shock table with acceleration sensor
during shock test in Z-axis, negative direction
