# CERTIFICATE of QUALITY TEST

Test report - No. 10996.06 / 14

Equipment under test Incremental Encoder POG 10 DN 1024 I

Test program Vibration, sinusoidal 20 g according to IEC 60068-2-6

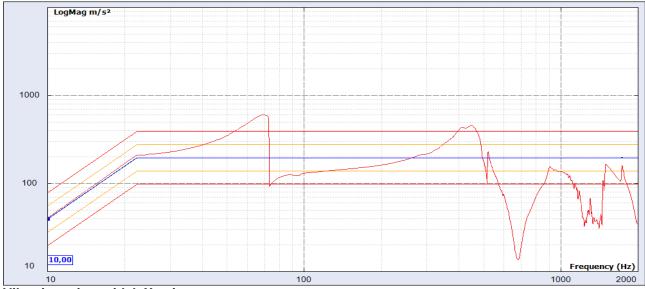
Vibration, sinusoidal, X-axis, - control channel, - acceleration at specimen (channel 3)

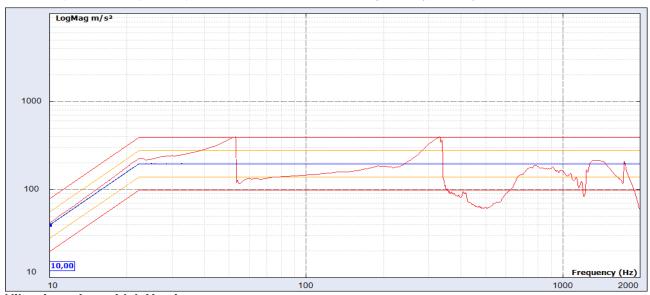
Vibration, sinusoidal, Y-axis, - control channel, - acceleration at specimen (channel 3)

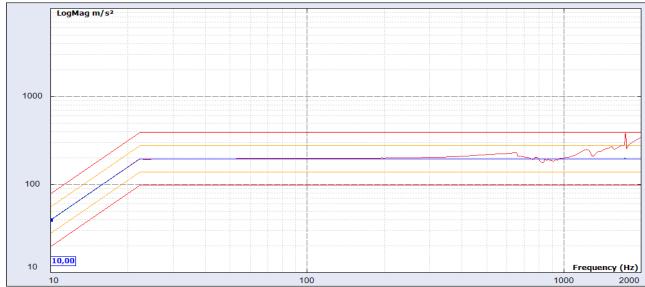
Vibration, sinusoidal, Z-axis, - control channel, - acceleration at specimen (channel 3)

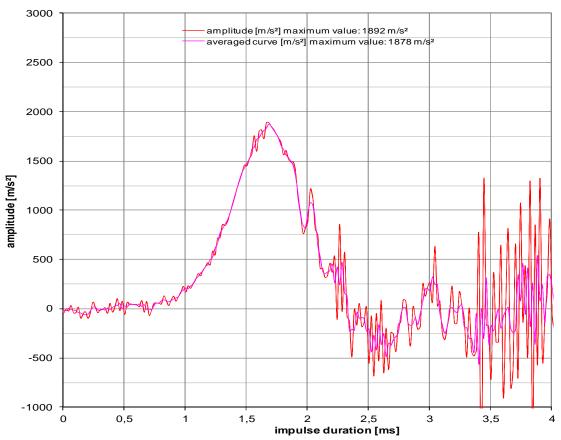
# Shock, half-sine (control channel)

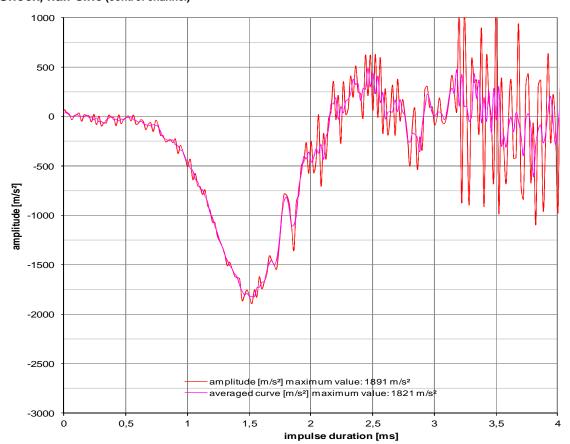
Shock, half-sine, inverted (control channel)
